Evaluation of the FCSs

3. Evaluation of FCSs

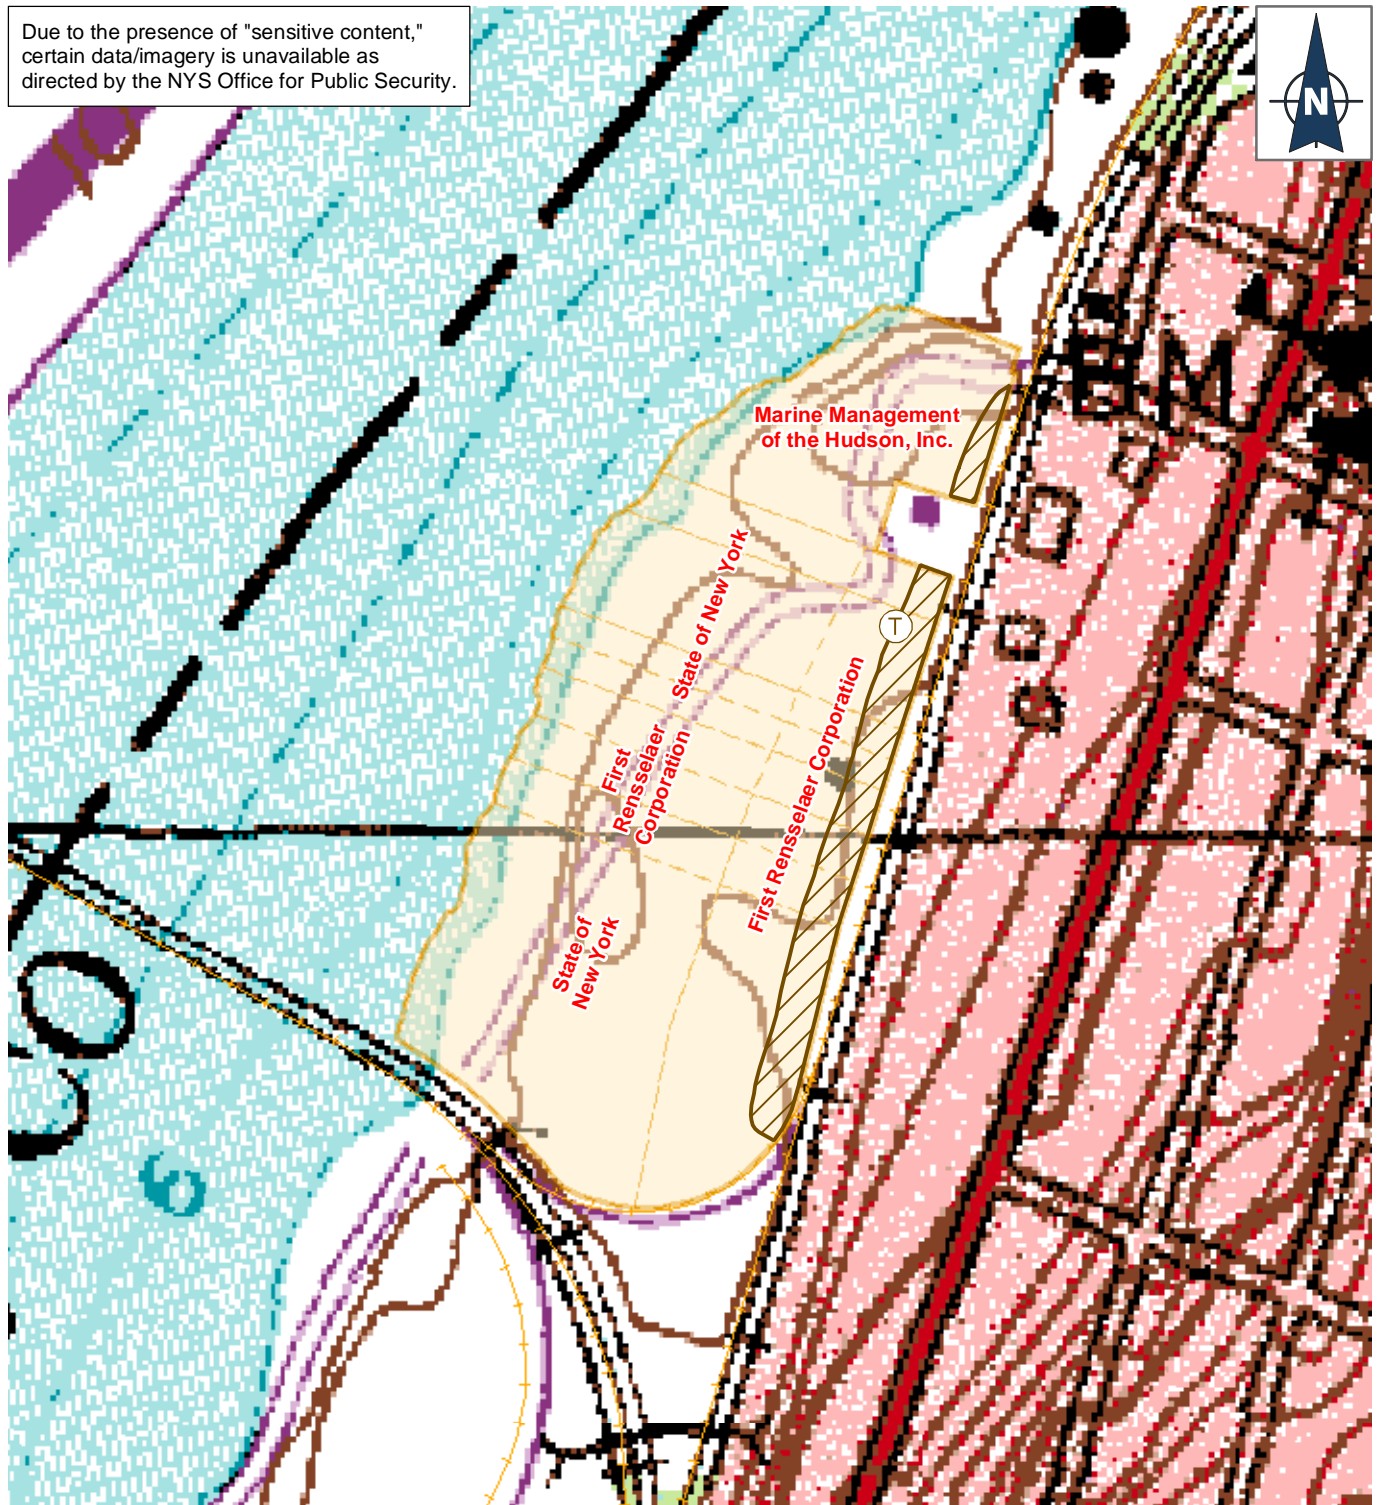
Figure 3.2.6-3
Field Sampling Areas
Phase I B Cultural Resources Investigation
State of New York / First Rensselaer / Marine Management

Ⓣ Backhoe Trench Locations

Archaeological Testing Method

Phase IB fieldwork was conducted on the State of New York/First Rensselaer/Marine Management site on November 14, 2003 (see Figure 3.2.6-3). The vast majority of the site is fill and made land. The survey discovered one historic foundation made from poured concrete. It has sectioned rooms, is surrounded by fill, and does not appear to be a significant historical or architectural resource. The Phase I field investigation is complete for this site.

Fieldwork was conducted October 25, 2003. Most of the site contains a modern landfill. One 10-meter long trench was excavated in the northern half of the site. It did not produce any features, artifacts, or paleosols. No evidence was found of the original shoreline indicated on historic maps.

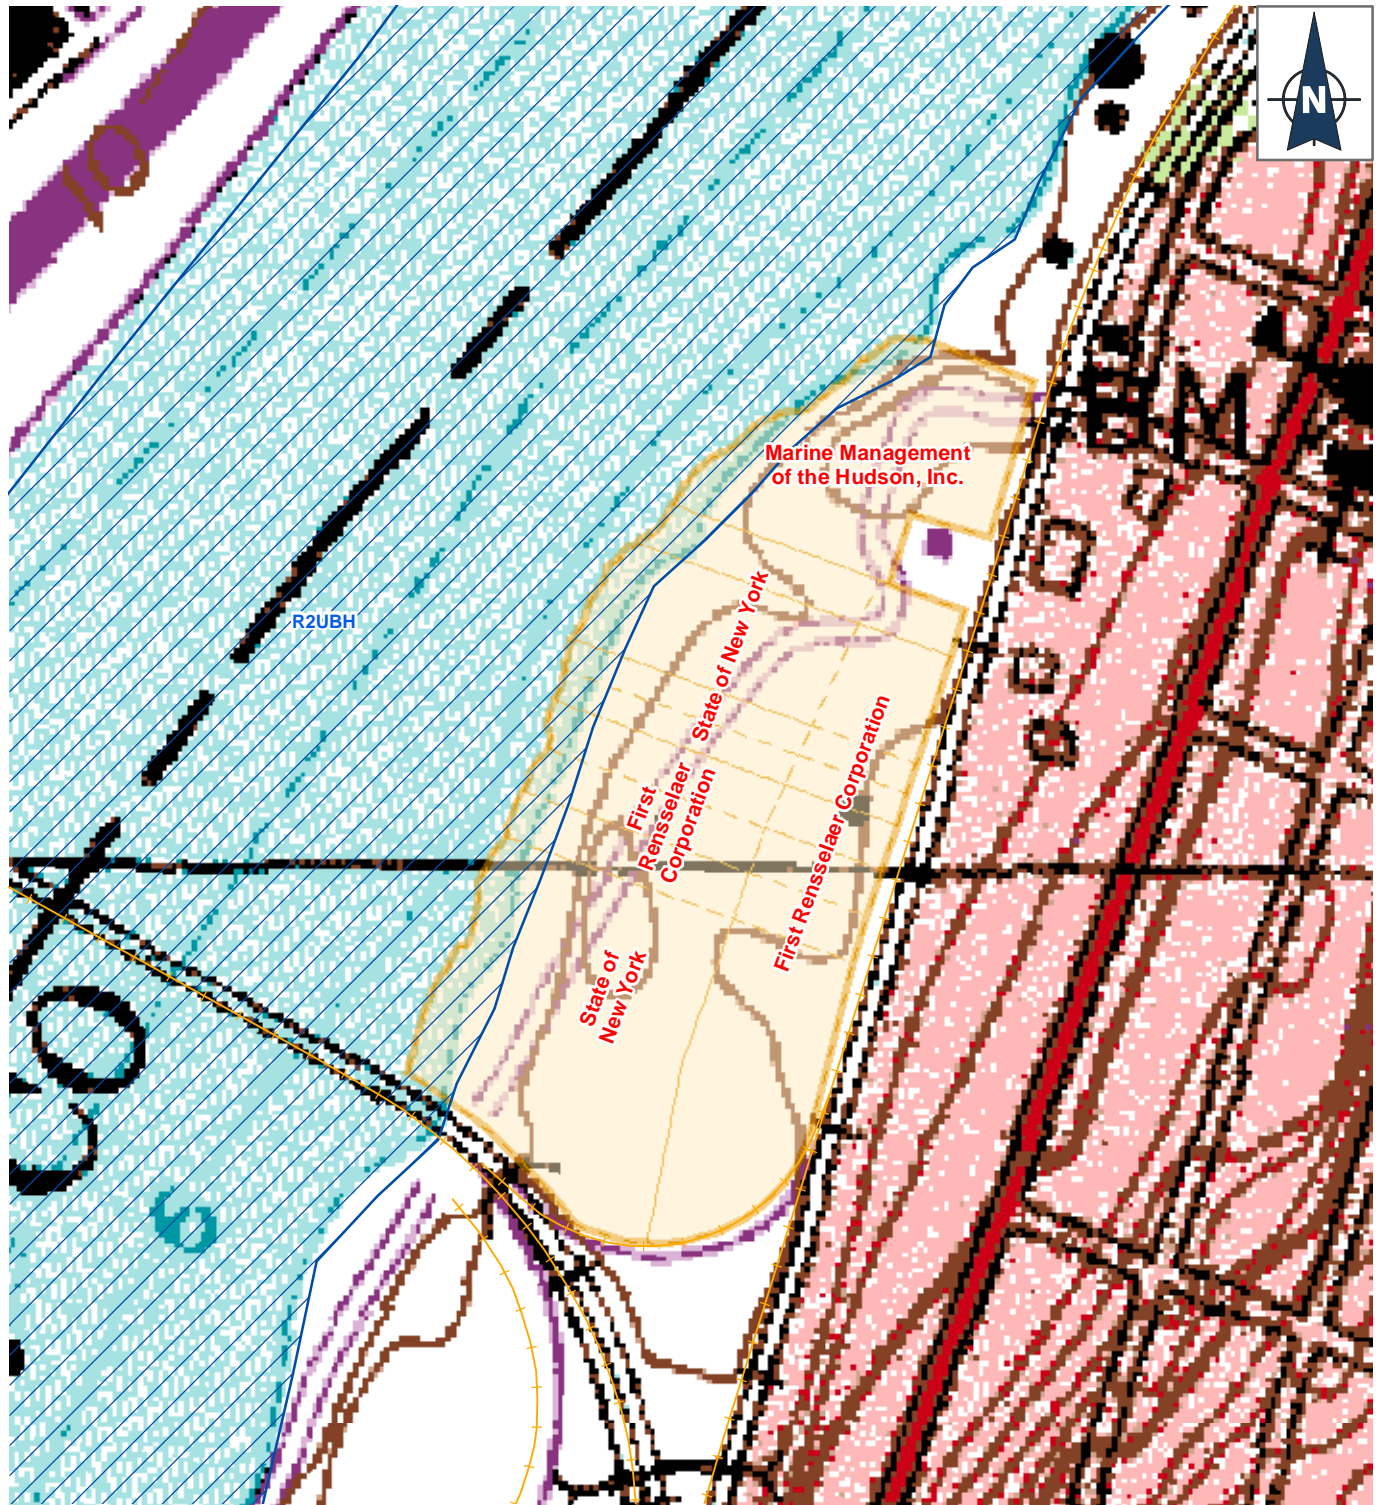
- NYS DEC Wetlands
- US Fish and Wildlife Wetlands

Review of NWI wetland mapping indicated the presence of a NWI-identified riverine wetland complex along the shoreline of the site. No further wetlands were identified on any of the parcels. Although NWI wetland maps identify entire river systems as riverine or lacustrine wetlands, sample plots and determinations along the shoreline were limited to areas that exhibited wetland characteristics and occurred above the ordinary high water mark. No NYSDEC wetlands were identified on the site.
